TM65

Mid-level Report

AG2: 2-1Gn Designline Ambient Gantry 800mm (Self Help)

Manufacturer CED Fabrications

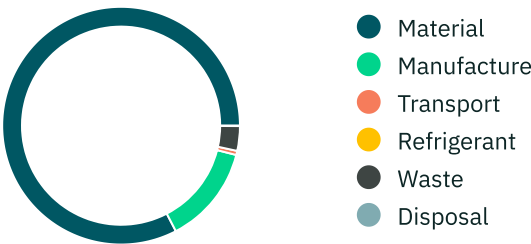
Embodied Carbon Footprint

Embodied Carbon
141 kgCO2e

| Embodied carbon results (kg CO2e) – breakdown | |
|---|---|
| A1: Material extraction | 71 kgCO2e |
| A2: Transport | 8 kgCO2e |
| A3: Manufacturing | 13 kgCO2e |
| A4: Transport to site | 0.42 kgCO2e |
| B3: Repair | 11 kgCO2e |
