TM65

Mid-level Report

PC15ASHTD + PAF2: Designline HT Cold Drop In Patisserie, assisted service, 1500mm + (Airflow Kit In-Out Operator Side)

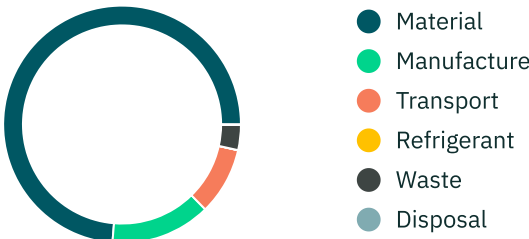
Embodied Carbon Footprint

Embodied Carbon

3,103 kgCO2e

A1: Material extraction	1,369 kgCO2e
A2: Transport	205 kgCO2e
A3: Manufacturing	325 kgCO2e
A4: Transport to site	10 kgCO2e
A5: Construction	N/A
B1: Refrigerant leakage during use	0.42 kgCO2e
B2: Maintenance (if information given by manufacturer)	N/A
B3: Repair	390 kgCO2e
B4: Replacement	N/A
B5: Refurbishment	N/A
B6: Operational energy	N/A
B7: Operational water	N/A
C1: Refrigerant leakage when decommissioning	0.02 kgCO2e
C2: Transport	3 kgCO2e
C3: Waste processing	81 kgCO2e
C4: Disposal	1 kgCO2e
