# TM65

## Mid-level Report

KPC9HTD + PAF1: Kubus HT Cold Drop In Patisserie, self service, 900mm + (Airflow Kit In-Out Customer Side)

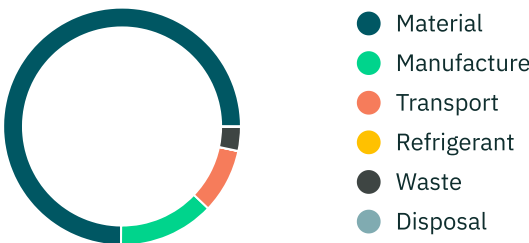
Embodied Carbon Footprint

A1: Material extraction	1,045 kgCO2e
A2: Transport	154 kgCO2e
A3: Manufacturing	244 kgCO2e
A4: Transport to site	8 kgCO2e
A5: Construction	N/A
B1: Refrigerant leakage during use	0.33 kgCO2e
B2: Maintenance (if information given by manufacturer)	N/A
B3: Repair	358 kgCO2e
B4: Replacement	N/A
B5: Refurbishment	N/A
B6: Operational energy	N/A
B7: Operational water	N/A
C1: Refrigerant leakage when decommissioning	0.02 kgCO2e
C2: Transport	3 kgCO2e
C3: Waste processing	61 kgCO2e
C4: Disposal	0.95 kgCO2e
