TM65

Mid-level Report

PC18HTD + PAF2: Designline HT Cold Drop In Patisserie, self service, 1800mm +
(Airflow Kit In-Out Operator Side)

Manufacturer CED Fabrications

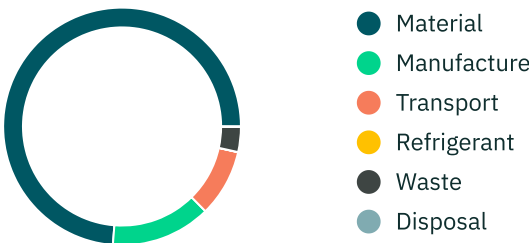
Embodied Carbon Footprint

A1: Material extraction	1,544 kgCO2e
A2: Transport	228 kgCO2e
A3: Manufacturing	361 kgCO2e
A4: Transport to site	11 kgCO2e
A5: Construction	N/A
B1: Refrigerant leakage during use	0.56 kgCO2e
B2: Maintenance (if information given by manufacturer)	N/A
B3: Repair	413 kgCO2e
B4: Replacement	N/A
B5: Refurbishment	N/A
B6: Operational energy	N/A
B7: Operational water	N/A
C1: Refrigerant leakage when decommissioning	0.03 kgCO2e
C2: Transport	4 kgCO2e
C3: Waste processing	90 kgCO2e
C4: Disposal	1 kgCO2e
