TM65

Mid-level Report

GWSEW3 + GTTS3: Glide (Wall Sited) Eutectic Well + Amb. Cupbd (No Gantry) + S.Steel Tray Rail 3-1Gn

Manufacturer CED Fabrications

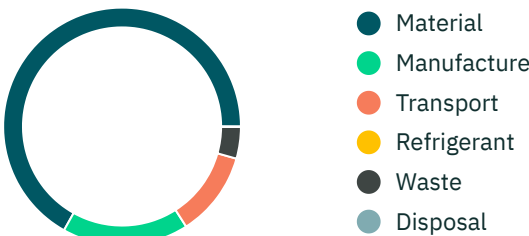
Embodied Carbon Footprint
