TM65

Mid-level Report

GEW5 + GAG5 + GSTS5: Glide Eutectic Well + Amb. Cupbd + Ambient Gantry (S.Help & A.Serve) + S.Steel Tray Slide 5-1Gn

Manufacturer CED Fabrications

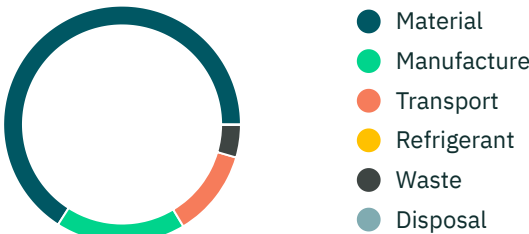
Embodied Carbon Footprint
