# TM65

## Mid-level Report

KMDR5ASHT+AF2: 5-1Gn Kubus Cold Multideck 1875mm - Rear Doors (Ass. Serve)  
+ (Airflow Kit In/Out Operator Side)

Assessment Date 31/10/2025

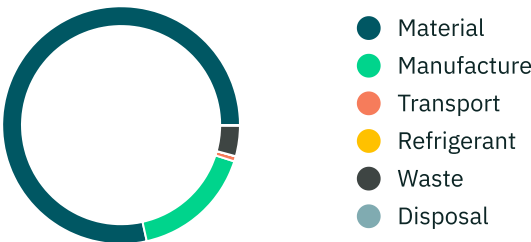
Embodied Carbon Footprint

Embodied carbon results (kg CO2e) – breakdown	
A1: Material extraction	1,471 kgCO2e
A2: Transport	242 kgCO2e
A3: Manufacturing	383 kgCO2e
A4: Transport to site	12 kgCO2e
A5: Construction	N/A
B1: Refrigerant leakage during use	0.55 kgCO2e
B2: Maintenance (if information given by manufacturer)	N/A
B3: Repair	341 kgCO2e
B4: Replacement	N/A
B5: Refurbishment	N/A
B6: Operational energy	N/A
B7: Operational water	N/A
C1: Refrigerant leakage when decommissioning	0.03 kgCO2e
C2: Transport	4 kgCO2e
C3: Waste processing	96 kgCO2e
C4: Disposal	2 kgCO2e
Embodied carbon results (kg CO2e) – without refrigerant leakage	
A1–C4 without buffer factor (excluding B1, C1)	2551 kgCO2e
A1–C4 with buffer factor (excluding B1, C1)	3316 kgCO2e
Embodied carbon result (kg CO2e) – refrigerant leakage only	
B1 (refrigerant leakage during use) + C1 (refrigerant leakage at end of life)	1 kgCO2e
Embodied carbon result with 'mid-level' calculation method – total
