TM65

Mid-level Report

MM15LHD + MMDR15L: 4 Tier 1500 Large Cold Merch. (Front Hinged Door) + (Rear Doors)

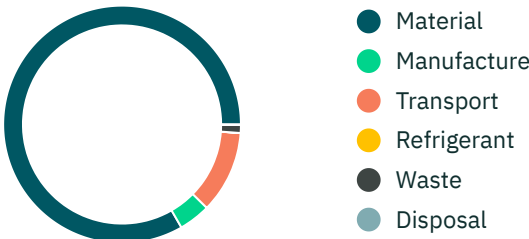
Embodied Carbon Footprint
